Accident Risk Factors in Conventional and High Speed Ferry Ships in Spain

Objective: studying the basic causes of marine casualties in conventional and high speed passenger ships over short distances (ferry ships). Identification of risk factors for most common accidents.

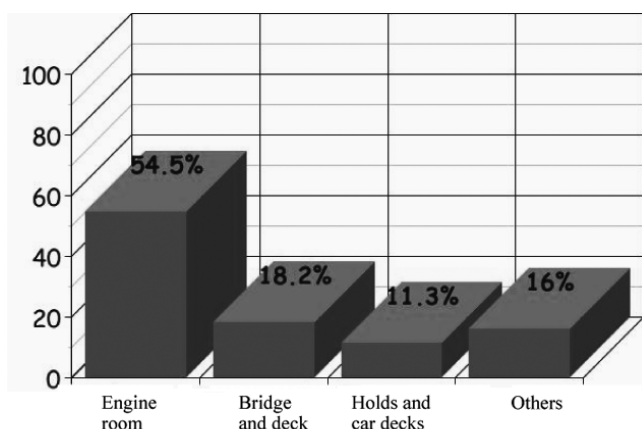
Figure 1. Deficiencies location.

As it can be seen in Figure 1, more than half of the identified deficiencies, as detailed later in this article, are located in the engine room (54.5%), then bridge and deck make together 18.2% (bad condition of facilities, lack of instruction, etc.), holds and car decks meet 11.3% (tins, cans, flammable goods, etc.) and finally 16% of deficiencies are found elsewhere not centralized (no order and bilge cleaning, bow thruster locker and other store rooms).

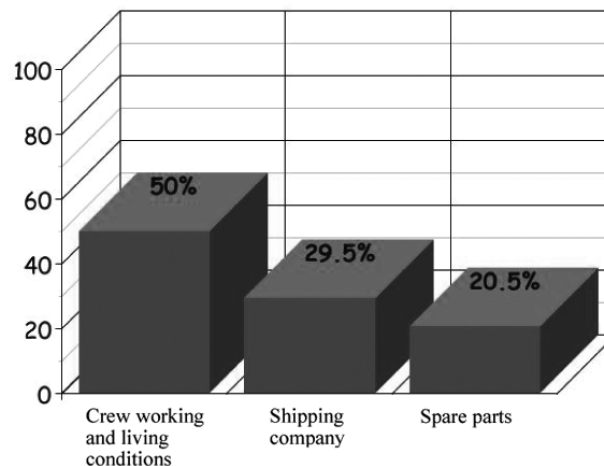
Figure 2. Deficiencies origin.

As for deficiencies found, Figure 2, it can be distinguished:

1. Those related directly with the crew, 50%: so as very short turnaround, excessive working hours, reduction in crew, lack of management and leadership.
2. Those that need an economic investment to be corrected (as well as change of company policy) 29.5%.
3. Those that should be solved by the crew, but they require resources from shipping company (spare parts, for example), 20.5%.

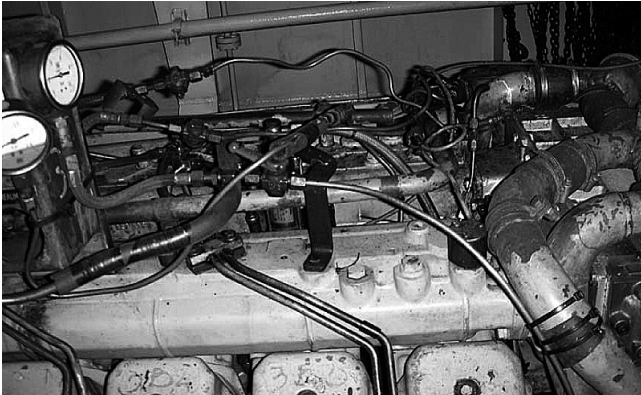
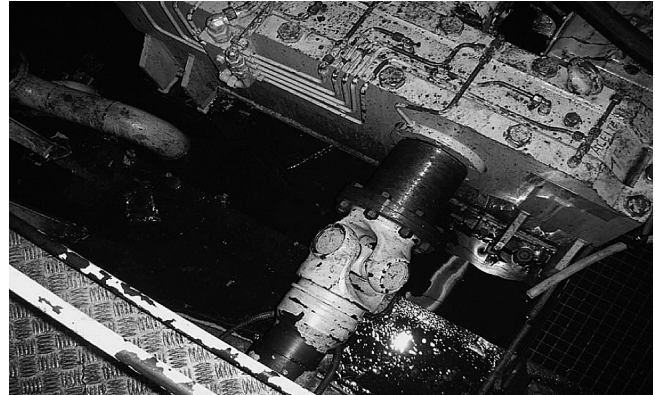
Figures 3. Most common deficiencies.

- The existence of hot surfaces (> 200 C in some places) without protection or thermal insulation in very poor condition, poor or lack of protection in hydraulic hoses and pipes that contain flammable liquids, along with excessive vibration in the hydraulic unit and fuel leaks are a clear fire risk factor (in addition to a clear deterioration in the environmental quality of the engine room) (Figures 3).
- The failure in detection and fire fighting systems, as well as crew lack of familiarity and training and with a clear margin of technical development, enhance further more, if possible, the paragraph above.

— Active alarms during navigation caused by damage and not repaired sensors, making it very difficult to distinguish a real alarm from a false alarm. The repetition makes officers think in false alarms (alarms, watertight doors, fire fighting doors, engine failure alarms).

— Absence of report of breakdowns, frequent inspections, control of preventive and corrective actions (deficiencies, mostly seems to be repeated over a period of four years), lack of predictive analysis, failure in the adequate communication between crews and intensive working days (two officers cover a shift of 24 hours due to the reduction in crews). All this form management conditions that need to be improved.

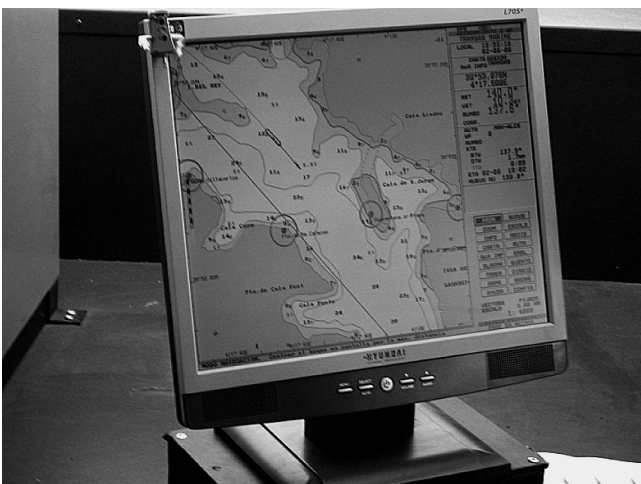
Figure 4. Voyage plan deficiencies

Other deficiencies, not related to the engine room or to maintenance, but listed as a cause of accident claims discussed in the following paragraph, are among others: electronic chart system is not connected to the radar (not listed positions of other vessels), absence of night vision binoculars, radar use in inappropriate scale, incorrect change or use of joystick, and lack of voyage plans (Figure 4).
