## Structural modelling of medieval walls

**ABSTRACT:** Medieval construction systems usually involved the construction of multi-layer walls formed by two faces of ashlar work or masonry with a central infilling consisting of rubble bound with mortar, generally lime-based. It is a simple and efficient construction system which continued to be used in subsequent centuries.

This paper tackles the problem and puts forward various possibilities of solution with different element types.. It also provides two examples of Gothic monuments in Galicia (Spain) in which structural behaviour was studied using some of these calculation models: the churches of Guimarei and Cambados.

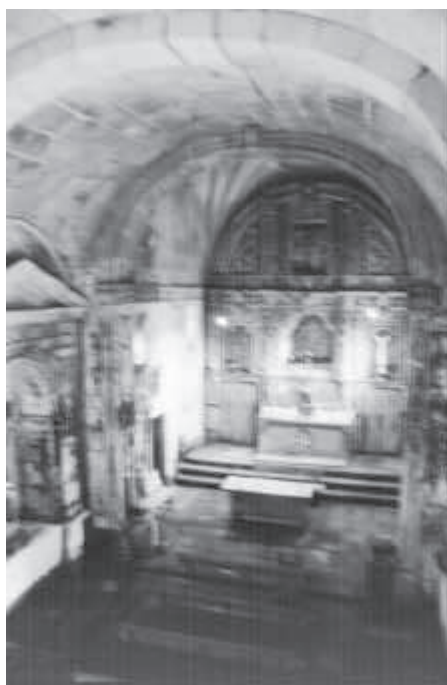
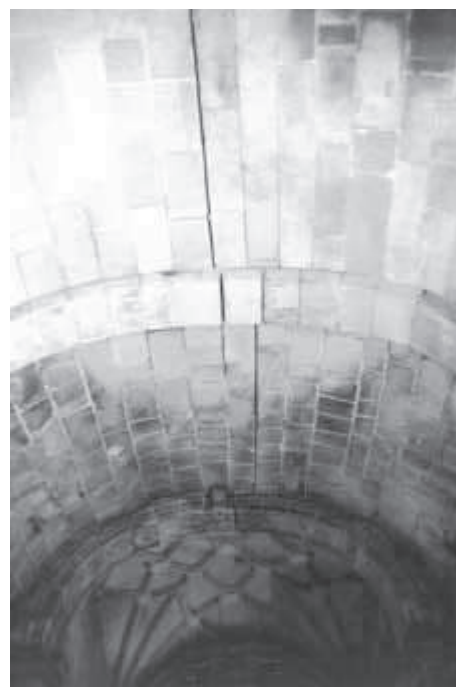
Figure 5 :Inner view of Guimarei

Figure 6 : Grietas in the vault

Examination of the leanings demonstrates that while the external face of the wall has hardly become inclined, the internal wall has suffered displacements of a great magnitude. Taking into consideration the facts that the vault is supported on the internal face and that rubble infilling deterioration has been verified, there were reasons to assume that the pressures of the vault had deformed the infilling, which had not been able to transfer it to the external walls and, hence, to the abutments. The state of the church interior with serious deformations in the vault, leanings in the lateral walls and the arch voussoir, that supports the choir and that has given way, are shown in figures 5, 6.

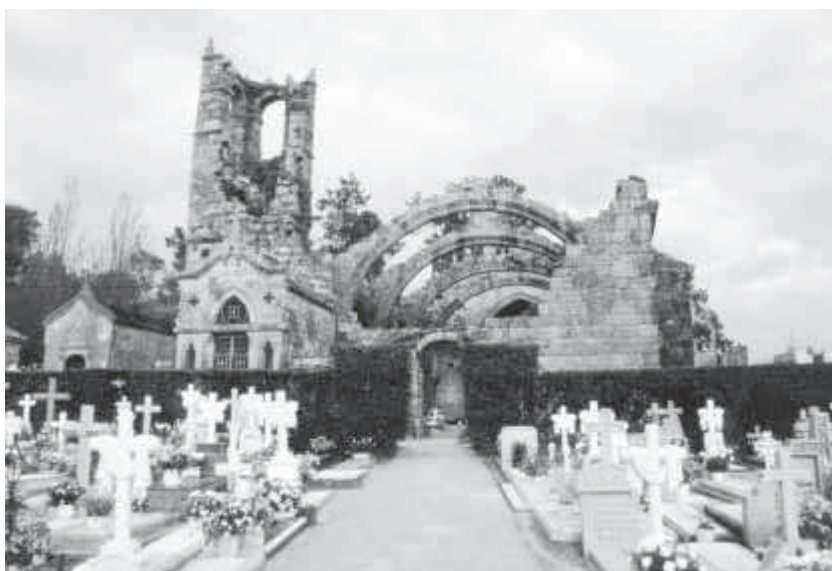
This is a late-gothic church, which is almost in ruins, thus facilitating the observation of the wall structure. Contrary to the preceding case, both faces of the wall are solidly bound, so the wall practically functions as a unit.

Figure 11 : Ruins of church at Cambados.

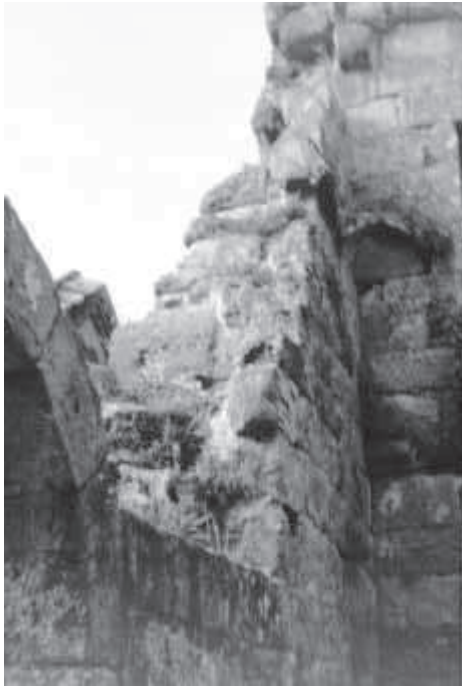
Figure 12 : Wall structure of church
