Restoration of the Palacio de Mayoralgo in Cáceres (Spain).

José Fernández Salas, Prof. University of A Coruña, Spain

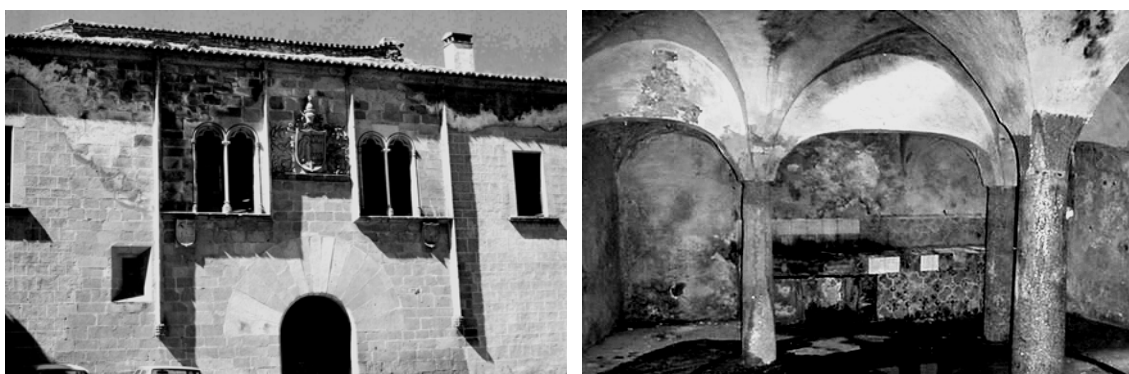
Figs. 4 and 5. The building was strongly degraded: main facade (left) and old kitchen (right).

Before the works the building was, as it has been indicated, on the edge of ruin, strongly degraded (figs 4, 5, 6 and 7). Among the causes of the physical degradation it is necessary to consider the bombing already mentioned of the Civil War that originated considerable damages in the main facade, in the roof and in the structure of walls and vaults that almost completely disappear. This situation forced the dwellers to leave the affected rooms and to move to other rooms in the building. They even had to carry out some urgent repair work at this delicate moment in the middle of the war. The facade and the roof were restored in the seventies, but the other damages could still be observed when the restoration began. From the moment that the family sold the building until it is acquired by the Caja de Extremadura and the restoration project was elaborated, ten years had passed during which the neglect was absolute, which increased the physical decay the building was suffering and caused ruin in some parts.

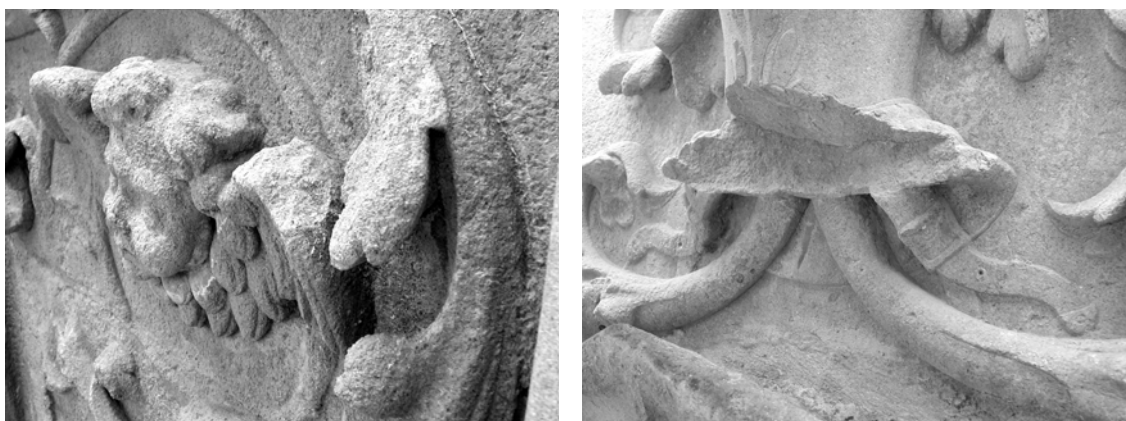
Figs. 6 and 7. Degradation of main facade in stone's sculptural iconography

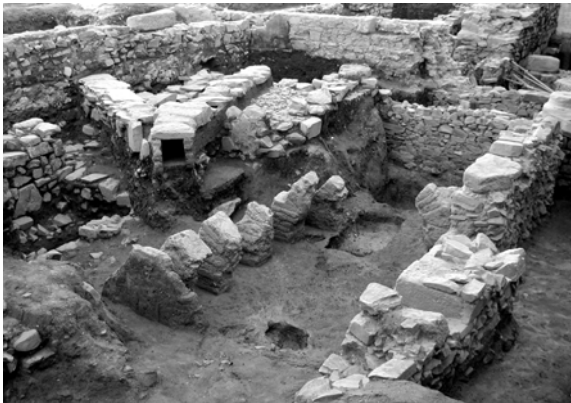
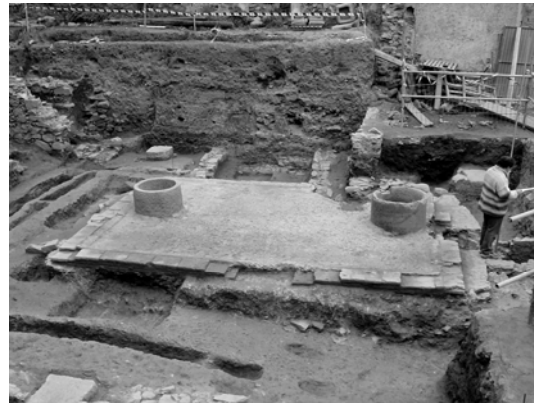
Figs. 7 and 8. Archaeological remains, 16th century: Romans hypocaust (left) and *aljibe* (water tank).

tion works begin in the Palacio for more than 2 years, between August 2001 and December 2003. The finding of the archaeological remains (figs. 7 and 8) at the beginning of the works forced some adjustments in the initial design in order to preserve and protect them. The archaeological importance and the need to incorporate the remains into the building suggested that we should start working in it once the main building was ready to be used. The works at the archaeological site are the third and last phase.

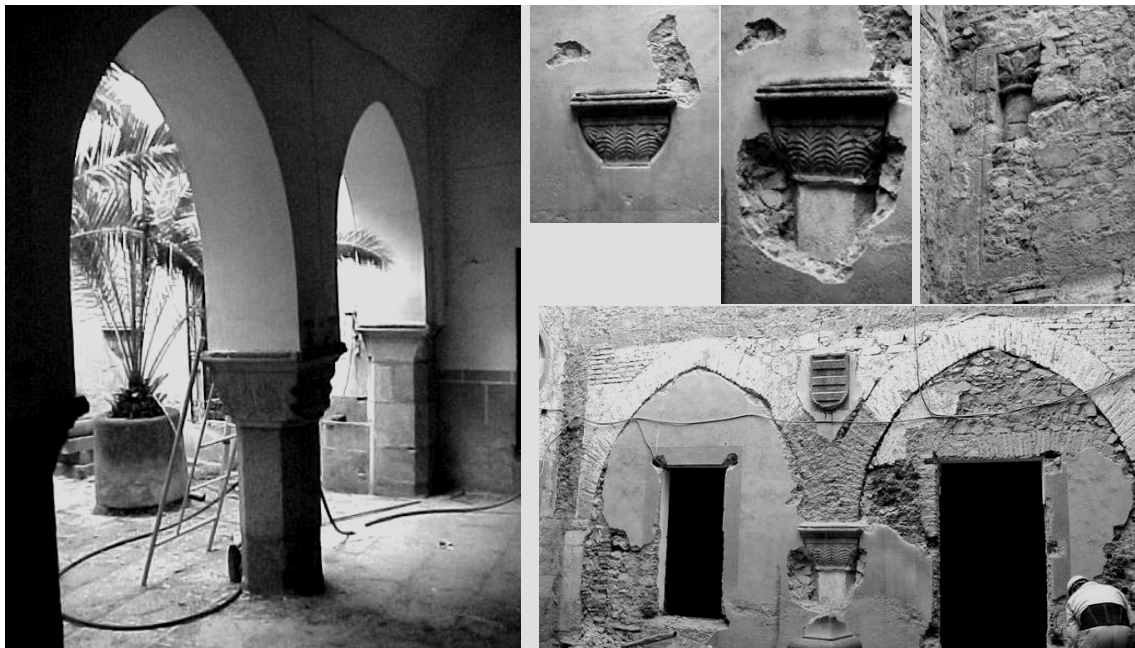
Fig. 9. Arches, in the central courtyard. In two columns appeared, with vegetable reliefs in their capitals that were evidence of a higher corridor.

A significant example may be the central courtyard. An apparently modest courtyard, almost vulgar before the works if it were not for the two arches that served as access from the main entrance and for some emblematic elements on doors and windows (fig. 9). However, hidden next to these arches, there were other two similar arches totally walled except for a capital that could be seen. When they were discovered their lateral stirrups appeared: two excellent granite pilasters which continued the initial arcade.

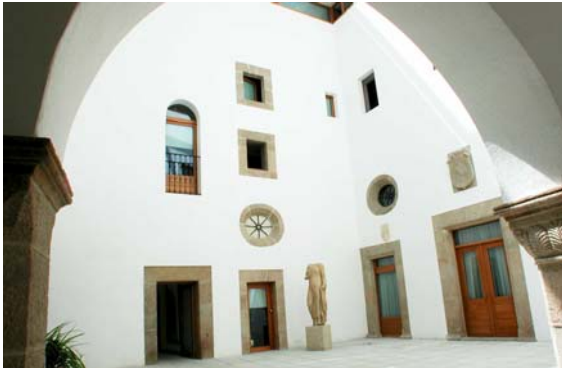
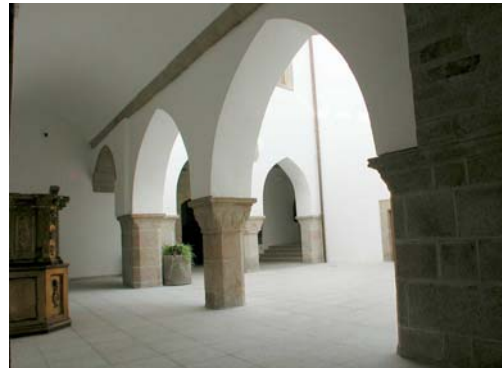
Figs. 10 and 11. Arches, in the central courtyard, after restoration.

On these arches, in a corner, two columns appeared, with vegetable relieves in their capitals that were evidence of a higher corridor. Since other rooms had already been fragmented, the cloister with the courtyard and the arches were hardly perceptible, and this forced the demolition of the walls that blinded the length of the corridor. It was only in this way that the integration of the fragmented parts in a splendid space unit could be achieved: the cloister, impossible to interpret starting from the degraded courtyard (figs. 10, 11 and 12). The whole, Aristotle said, is more than the sum of its parts.

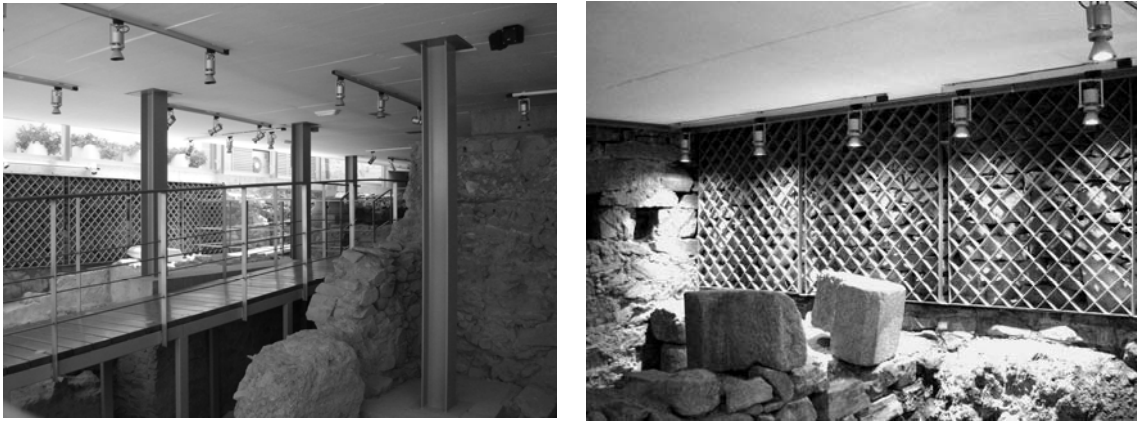
Figs. 18 and 19. Visitable remains in a crypt (lowest part in the courtyard). Grating remembers the Roman “opus reticulatum”.
