Rates of stone recession on Mediaeval monuments: some thoughts and methodological perspectives

ANDRÉ, M. F.¹ and PHALIP, B.²

Key words: Rock weathering, stone decay, weathering rates, Mediaeval monuments, Romanesque churches, Angkor temples

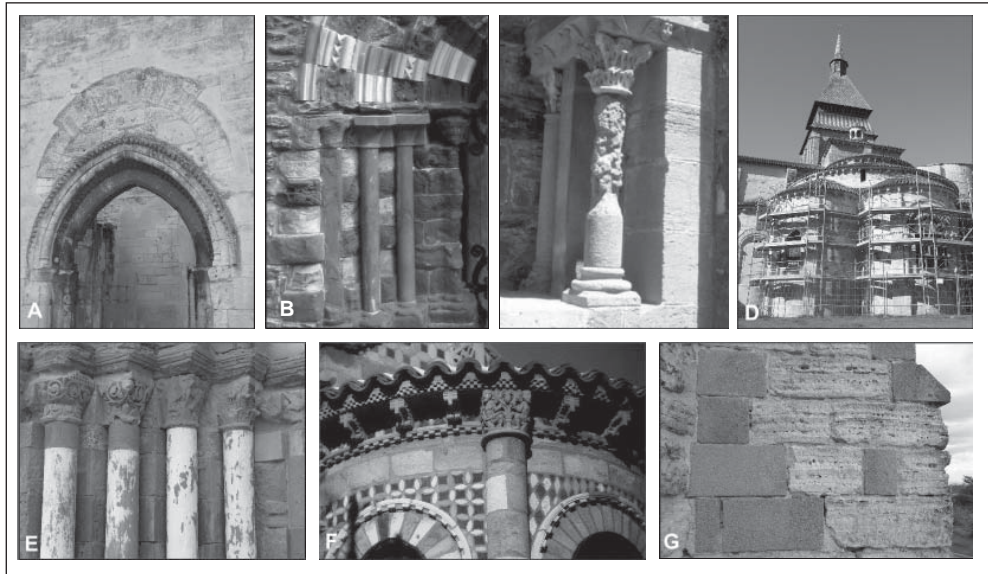
Fig. 1. Polygenetic origin of 'Mediaeval' European churches. © M. F. André

A. Mid-12th century Gothic arch inserted in late 11th century Romanesque arch (Saint-Front Cathedral, Périgueux, Dordogne, 21-11-08). B. Decayed and replaced sandstone elements in early 13th century portal (Saint-Magnus Cathedral, Kirkwall, Orkney Islands, 27-7-1987). C. Intriguing weathering pattern on a Mediaeval column (Sainte-Foy abbey church, Conques, Aveyron, 18-6-00). D. Contemporary restoration site (Sainte-Valérie abbey church, Chambon-sur-Voueize, Creuse, 19-10-08). E. Late 12th century whitewashed portal columns (Notre-Dame church, Fleuriel, Allier, 15-10-08). F. Polychrome apsidiole, restored in mid-19th c. and cleaned in the early 2000s. (Notre-Dame du Port church, Clermont-Ferrand, Puy-de-Dôme, 31-1-06). G. Original limestones and darker arkosic sandstones incorporated during the 1995-2000 restoration (Sainte-Martine church, Pont-du-Château, Puy-de-Dôme, 4-10-08).

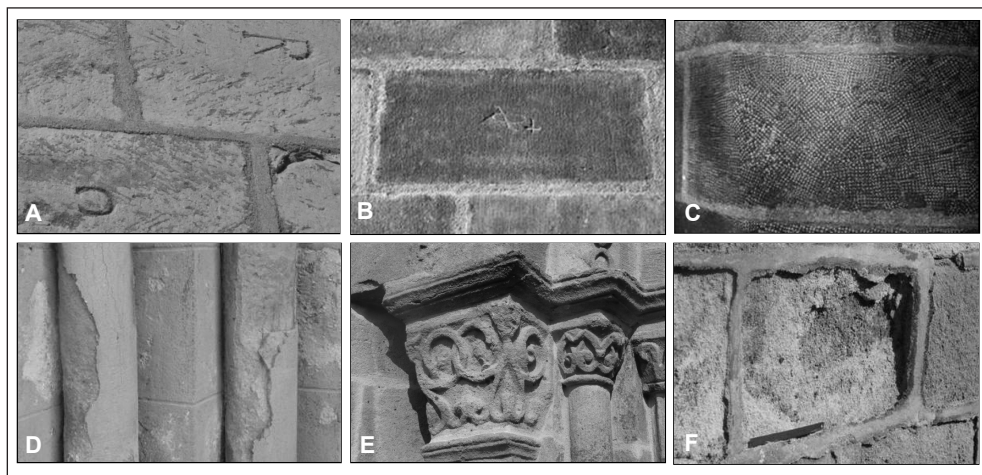
Fig. 3. Zero-datum levels provided by Mediaeval churches of the Massif Central. © M.-F. André

A. Late 12th century 'fern-leaved' or 'fishbone' finish and mason's marks on arkosic sandstone (Saint-Austremoine abbey church of Issoire, Puy-de-Dôme, 18-10-08). B. 14th century brettelé finish and mason mark on trachyandesite (Clermont-Ferrand Cathedral, Puy-de-Dôme, 31-1-06). C. Bush-hammered trachyandesite stone, 19th century (Michel de l'Hospital's Place, Clermont-Ferrand, Puy-de-Dôme, 31-1-06); in a Mediaeval monument, a bush-hammered stone surface indicates a post-late 18th century, often 19th century, restoration. D. Late 12th century sandstone door jambs affected by scaling (Saint-Martin church, Besson, Allier, 29-09-08). E. Mid-12th century ornamented capitals in arkosic sandstones (Saint-Pierre church, Gipy, Allier, 29-09-08). F. Cement mortar joints in arkosic sandstones (Saint-Marc church, Souvigny, Allier, 29-9-08).

WINKLER, 1986; INKPEN, 1998; MOTTERSHEAD, 2000b). Of special interest to the inventory of reference surfaces provided by Mediaeval monuments, are four exploratory studies conducted in Brittany and Auvergne, France (PARIS, 1998; MAGRÉ, 1999; BONNEAU, 2001; ROBERT, 2002; see also SELLIER, 1998, and MAGRÉ et al., 2007). Based on these studies, and on complementary fieldwork by the authors in the Massif Central (PHALIP, 2001; ANDRÉ et al., 2007b) and in Cambodia (ANDRÉ, 2006; ANDRÉ et al., 2008), a variety of zero datum levels can be listed (Table 2, figures 3 and 4).

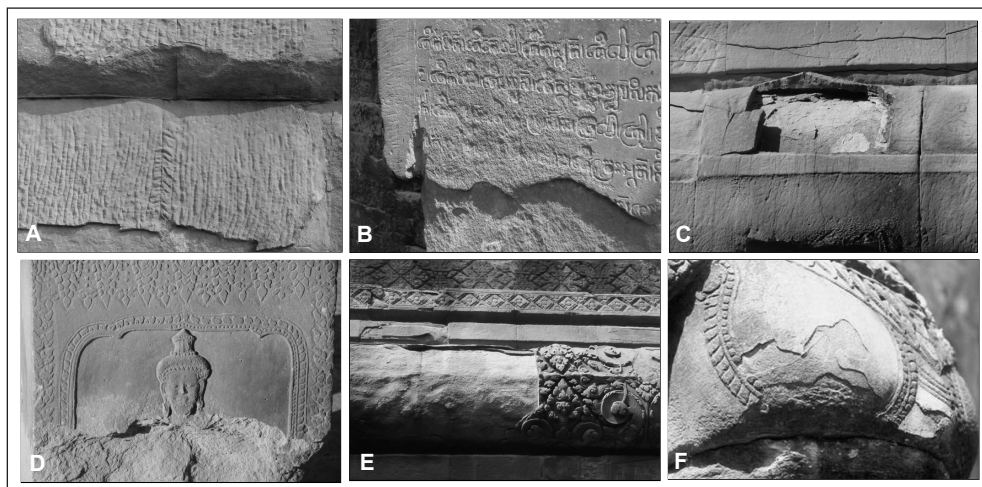
Fig. 4. Zero-datum levels provided by sandstone Khmer temples to evaluate recession depth from scaling and flaking (Angkor, Cambodia). © M.-F. André

A. Stone dressing marks (Ta Keo temple, South face, second tier, early 11th century, 7-2-08). B. Stele with inscriptions (Lolei temple, 9th century, 20-3-08). C. Moulded surface (Ta Keo temple, South face, first tier, early 11th century, 6-12-08). D. Ornamented pillar (west gallery, Angkor Wat, 12th century, 6-12-08). E. Scaling decorated toric rib (eastern face, Ta Keo temple, early 11th century, 6-2-08). F. Flaking sandstone on the polished surface of a garuda statue (terrace of the elephants, Late 12th century, 28-12-04).

Stone-dressing marks provide authentic reference surfaces on the wall facings of churches and temples dating back as far as the Antiquity (e.g. BESSAC, 1986, 1993; PARADISE, 1998, 2005). Good inscription and dressing marks are more likely to survive on sandstones, limestones, marbles, and hard volcanic rocks, than on for example conglomerates and coarse-grained granites. In Mediaeval churches, stone-dressing marks can be classified in three major categories: (1) 12th century stones with their mason marks and fern-leaved or 'fish-bone' finish, with irregular and obliterated furrows every 5 mm (see figure 3a); (2) 13-15th century *brettelé* finish (see figure 3b); (3) 19th century bush-hammered finish (see figure 3c). This chronological succession provides a general framework whereby reference surfaces can be identified, but the reliability varies according to regions and monuments. Close cooperation with archaeologists of the Mediaeval period is required to ensure the chronology of stone-dressing marks, as it is to detect Mediaeval re-cuts of Gallo-Roman stones and 19th-21st century imitations of Mediaeval stone dressing techniques, with very sharp 1-2 mm-spaced tooling marks. In Cambodian sandstones, stone-dressing marks are mostly represented in the least ornamented or unfinished parts of temples (figure 4a).

In Romanesque churches, moulded surfaces are present in cornices, drips and portals, with polychrome archivolt of special interest when quantifying selective weathering (as long as stones have not been replaced). In portals of Mediaeval churches, door jambs can be systematically used to measure stone recession, for they display standardized sections, either cylindrical (in Romanesque style, cf. figure 3d) and/or polygonal section (in Gothic style). The polished surface of door jambs and columns can be preserved, particularly in marble, but this material often comes from Gallo-Roman columns, reused during the Middle Ages. Therefore, the chronological control of the datum is not easy to establish precisely. Edges of cornerstones can be used to quantify stone recession, though because of the sensitivity to weathering of their sharp edge, their use leads to over-estimations of the amount of weathering (as do, the measurements taken at the base of monuments, where accelerated weathering operates within the capillary fringe). In Cambodia, the numerous pillars of the Khmer temple galleries can be used to quantify historical weathering, together with horizontal mouldings such as toric ribs which are affected by scaling (figure 4c).

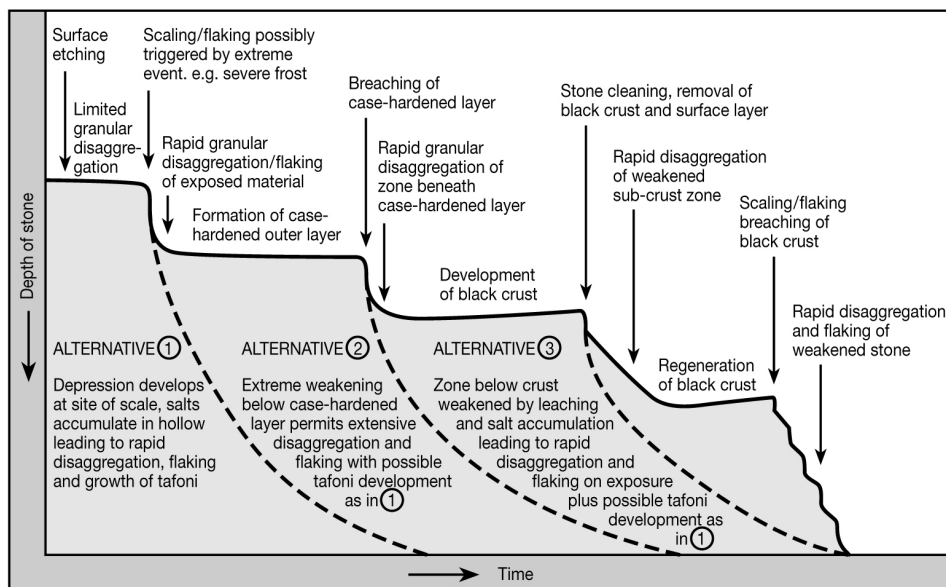
Fig. 5. Stone decay: a pulsatory process (SMITH et al. 1994).

Average rates of stone recession expressed in millimetres per century or millennium are relevant for comparison purposes between different lithologies or environments, but the mean values derived pertain to a suite of weathering processes and frequently mask the non-linear nature of weathering rates over time (POPE et al., 2002). At the centennial to millennial scales, previous weathering studies have suggested constant rates over time (e.g. PETUSKEY et al., 1995; MOTTERSHEAD, 1997), decreasing rates (e.g. WINKLER, 1973; MATSUKURA and MATSUOKA, 1991; ROBINSON AND WILLIAMS, 1996, see Fig. 6A; MAGRÉ, 1999), and increasing rates (e.g. KLEIN,

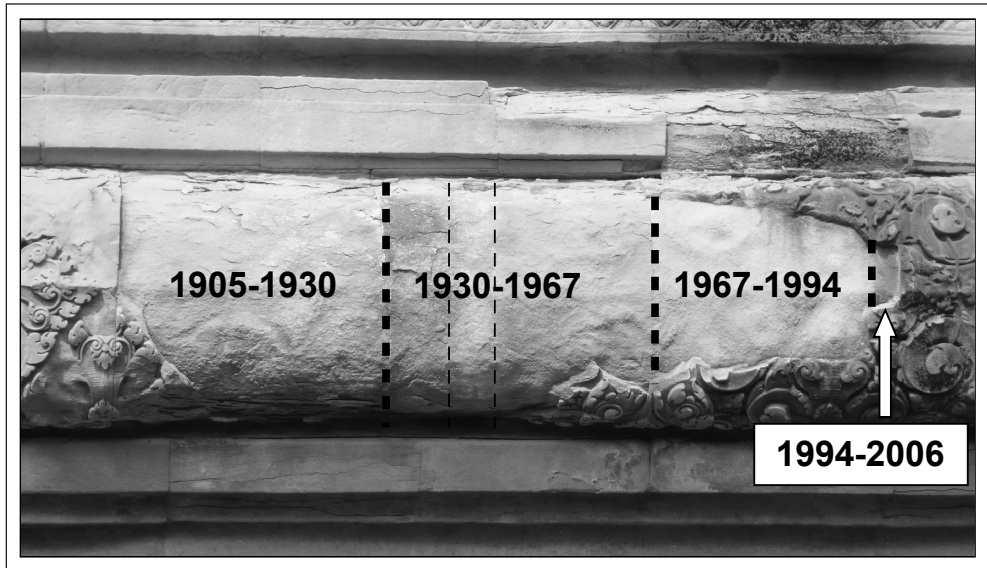
Fig. 6. Scenario of formation and development of an ‘erosion’ scar on an ornamented sandstone toric rib, reconstructed after a collection of old photographs (first tier of the eastern face of the central pyramid of Ta Keo temple, early 11th century, 19-3-08). © M.-F. André

lections, and a methodical and determined photographic hunt is needed. For example, figure 6 documents the formation and development of an ‘erosion’ scar during at least six scaling episodes over the 1905-2006 period, on a toric rib of Ta Keo temple. More extensive photogrammetry being undertaken on the sculpted facings of the central pyramid of this temple-mountain, is based on integra-

tion of orthorectified photographs with the MapInfo GIS (ANDRÉ et al., 2008). This diachronic approach is useful both in the reconstruction of the calendar of decay and in the tentative prediction of future damage, or at least the delineation of risk zones (based on scenarios of degradation, which differ according to the sculpted levels).

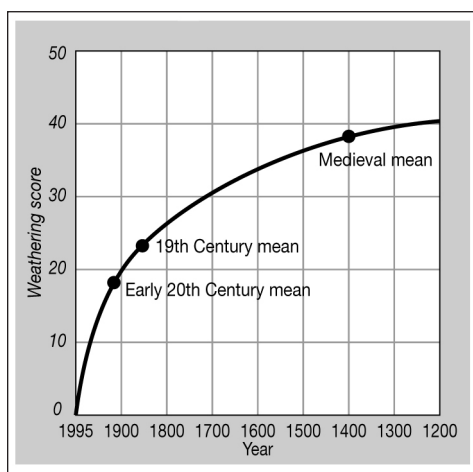
Fig. 7. Graph showing mean weathering scores for churches of different ages in Hastings Beds sandstones of central Weald, SE England (ROBINSON and WILLIAMS, 1996, Fig. 12.7 p. 144).

In England, ROBINSON and WILLIAMS (1996) have investigated heterochronous Wealden sandstone churches and question the significance of the resulting curve (figure 7). This suggests either a gradual decrease of decay due to the formation of protective crusts or patinas over time, or a contemporary acceleration of decay, possibly due to pollution and acid deposition. Such an acceleration is also suggested by BONNEAU (2001) in a preliminary study on the Romanesque and Neo-romanesque sandstone churches of the French Massif Central.

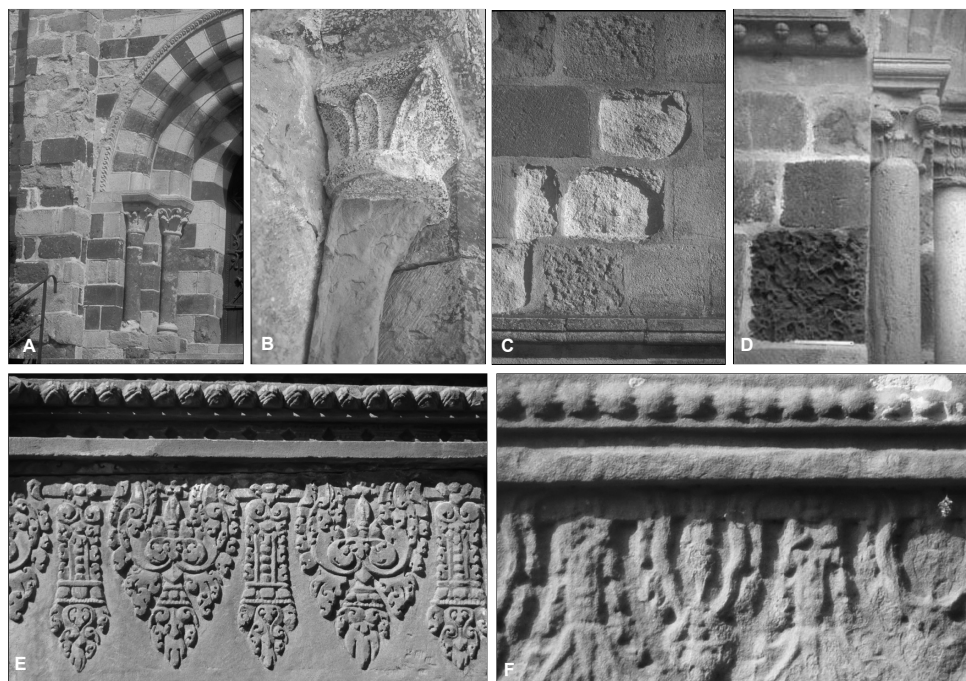
Fig. 8. Selective weathering in Mediaeval monuments: examples from Massif Central churches and Angkor temples. © M.-F. André

A. Well preserved laterite blocks and decayed light-coloured granites on the left (Saint-Didier church, Saint-Dier-d'Auvergne, Puy-de-Dôme, 22-4-01). B. Well preserved limestone capital and severely decayed psammitic sandstone door jamb (Saint-Barthélémy church, Estivals, Corrèze, 16-6-00). C. Well preserved iron-rich sandstones and decayed white sandstones (Saint-Prejet church, Malicorne, Allier, 10-1-01). D. Enigmatic alveolized reddish sandstone block (Saint-Jacques-le-Majeur church, Villefranche-d'Allier, Allier, 10-1-01). E. Well preserved decorative pattern in pink sandstone (Banteay Srei temple, 10th century, 7-12-08). F. Decayed decorative pattern in grey sandstone (East Mebon temple, 10th century, 7-12-08).

The polychrome Romanesque churches of the Massif Central are particularly suitable for comparative measurements of stone recession (figure 8a–8d). These monuments are particularly abundant in the sandstone-rich Brive, Espalion and Limagne basins, which are surrounded by basement rocks and/or limestones or volcanics. Studies are in progress, but as a working hypothesis, the following scale of increasing durability can be suggested (Table 1; see also ANDRÉ et al., 2007b): (1) weak limestones, (2) chlorite/biotite-rich granites, (3) oolitic and bioconstructed limestones, and magmatic rocks such as basalt, trachyandesite and leucocratic granite. The behaviour of sandstones is highly variable, with some arkosic sandstones as the most durable building stones, that display well preserved Mediaeval builder's and dressing marks (Issoire abbey church, Puy-de-Dôme, cf. MOREL, 2003), and some psammitic sandstones as the least resistant (Estivals church, Corrèze, cf. figure 8b). This last example of heavily weathered sandstone is comparable with 'the most severe cases of stone decay' and 'loss of carved detail' reported from the recent assessment of sandstone Irish monuments (PAVIA and BOLTON, 2001).

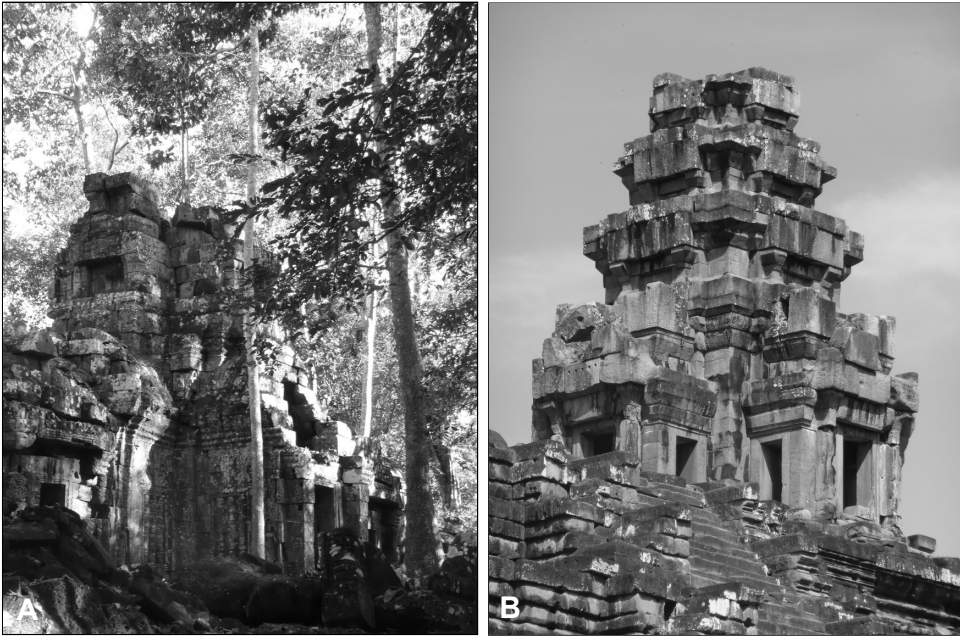
Fig. 9. Forested environment at Ta Nei temple (A) and non forested environment at Ta Keo temple, cleared from the forest in the 1920s (B). © M.-F. André (left: 8-12-08; right: 4-12-08).

Following an exploratory survey of 17 Angkor temples (ANDRÉ, 2006), the main objective of the ongoing Ta Keo research project is to assess the pre- and post-clearing rates of stone decay on the central pyramid of this temple-mountain (ANDRÉ et al., 2007a). Ta Keo temple has remained practically untouched since building (c. 1000 A.D.). It was surrounded by forest for some five centuries before the forest clearing of the 1920s. The history of the contemporary stone decay at the surface of its sandstone facings is documented by photographs covering the period 1905-2008 (figure 6). Therefore, it provides a rare opportunity to evaluate the impact of recent forest clearance on stone decay. Various sampling strategies were developed to assess weathering rates, based on a combination of methods such as photogrammetry, laser scanning and manual measurements of stone recession. Comparisons were made with Ta Nei, a neighbouring temple still located in a forested environment (figure 9), regarding both the state of deterioration of similar decorative patterns and the climatic conditions (meteorological monitoring in progress). The first results point to a contemporary acceleration of stone decay, with the area of deteriorated surfaces having tripled between 1963 and 2008 on the investigated test-zone

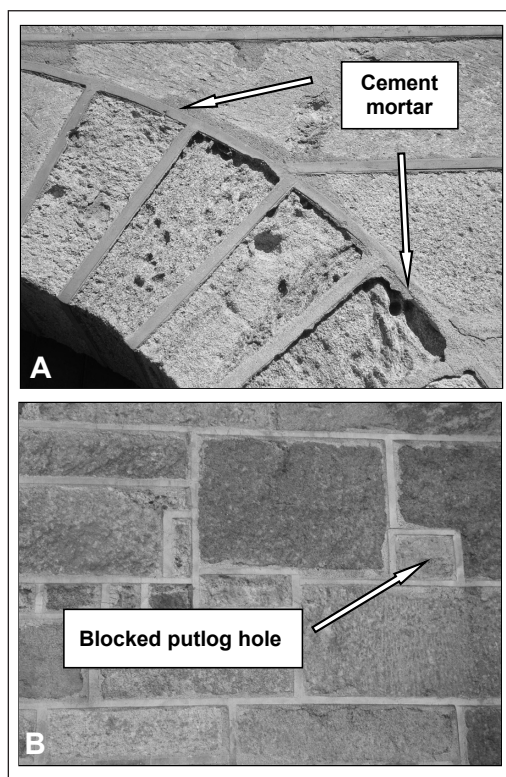
Fig. 10. Repointing with cement mortar and obturation of putlog hogs: a widespread practice between 1860 and 1950 in the Mediaeval churches of the French Massif Central. Examples are from two Puy-de-Dôme abbey churches: Saint-Sébastien of Manglieu (A) and Saint-Austremonie of Issoire (B). © N. Duracka / M.-F. André.

introduction of watertight Portland cement and the blocking of putlog holes (figure 10) caused drastic changes in the water balance and the chemistry of masonry stones (e.g. HERNÁNDEZ, BALLESTEROS AND ARNAU, 1993). They caused accelerated granular disintegration (e.g. GRUNAU, 1971; COLLOMBET, 1989). In rural areas of the Massif Central, the most severe damage occurred from the end of the 19th century to the middle of the 20th, due to the replacement of lime mortars by cement mortars, e.g. on Saint-Nectaire church, Puy-de-Dôme (PHALIP and ANDRÉ, 2008). In Brittany, measurements on nine granite churches located in non polluted environments suggest that post-repointing weather-

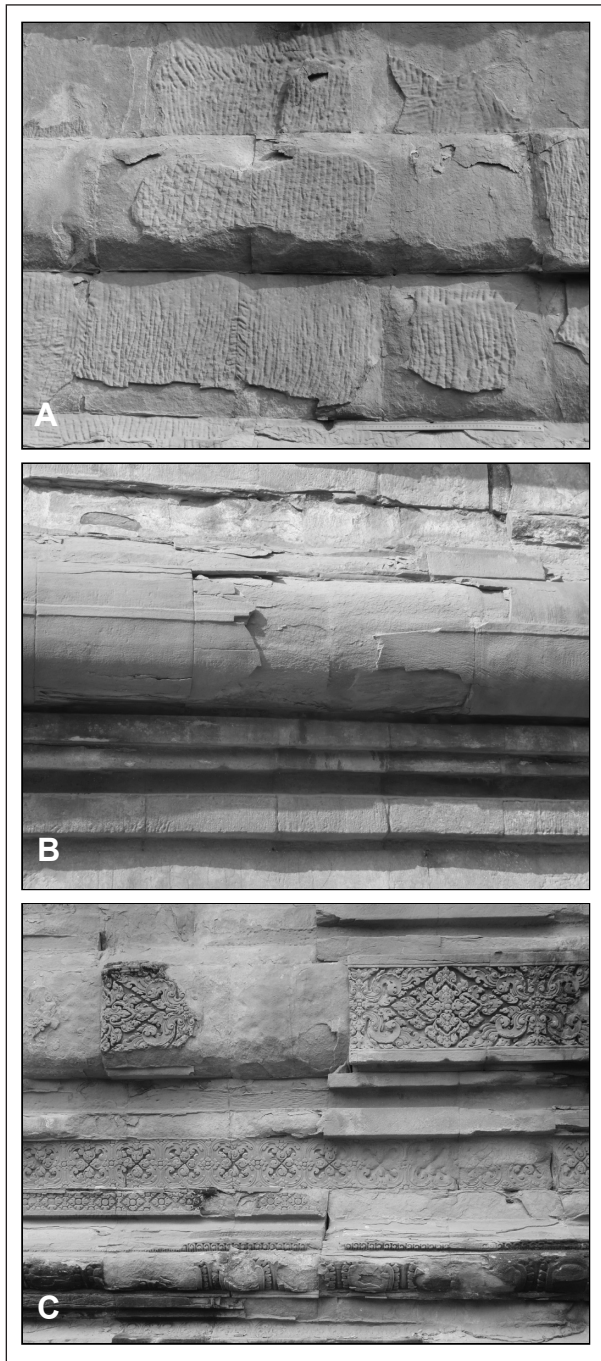
Fig. 11. Three types of stone finish on sandstone facings of the central pyramid of Ta Keo temple, Angkor. © M.-F. André.

A. Rough-hewn stones. B. Moulded stones. C. Chiselled stones.

1994, 1996), and recently investigated by McCABE et al. (2007b), based partly on laboratory simulations. Among the wide range of inheritance effects, stone processing was identified long ago as a major control on patterns and rates of stone decay (e.g. SCHAFFER, 1932). Quarrying, dressing and carving of stone can induce or reveal structural weaknesses in the building stone material. For example, the use of explosives for stone extraction and of bush hammers for stone dressing can induce macrofracturing or microcracking, paving the way to further weathering processes. Of course, the sensitivity of stone to such operations depends on its inherent properties. The impact of the Mediaeval and recent stonemasonry techniques on European monuments deserves further investigations, as does the mode of incorporation of stones into the structure. For instance, checked weathering patterns in Romanesque churches are frequently linked with the alternating placement of stones in parallel and perpendicular to bedding planes (e.g. in the Escurolles church, Allier – see photo 52 in BONNEAU, 2001 p. 117). In Cambodia, accelerated decay due to vertical stone placement is widespread at the base of pillars in the Angkor Wat galleries (ANDRÉ, 2006). The unfinished Ta Keo temple offers exceptional conditions whereby to assess the role of stone processing in the amount and forms of stone decay, and comparative studies of dressed, moulded and delicately ornamented sandstones are in progress (figure 11).

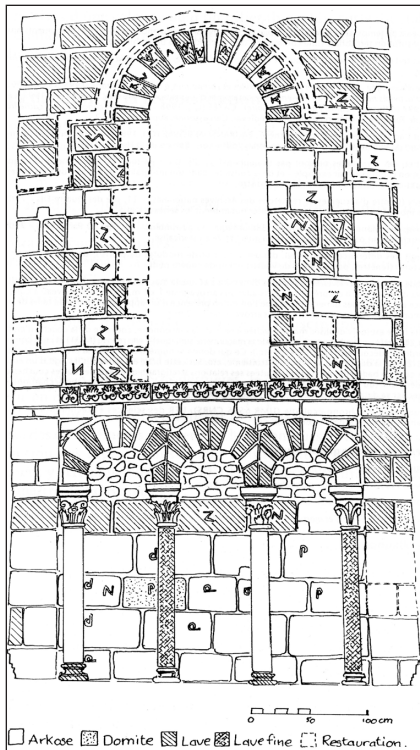
Fig. 12. Stone by stone mapping of the axial ambulatory window of Chamalières church, Puy-de-Dôme, by Yves Connier, stonemason (CONNIER, 2000, Fig. 1 p. 266).

Domite = Puy-de-Dôme trachyte; Lave = Vesicular lava; Lave fine = Close-grained lava; Restauration = Restoration.
