# Case study of safe working conditions in spanish merchant ships

*This paper aims to show a practical case study of safety assessment concerning possible injuries and fire occurring in the engine room on-board a merchant ship, due to fatigue.*

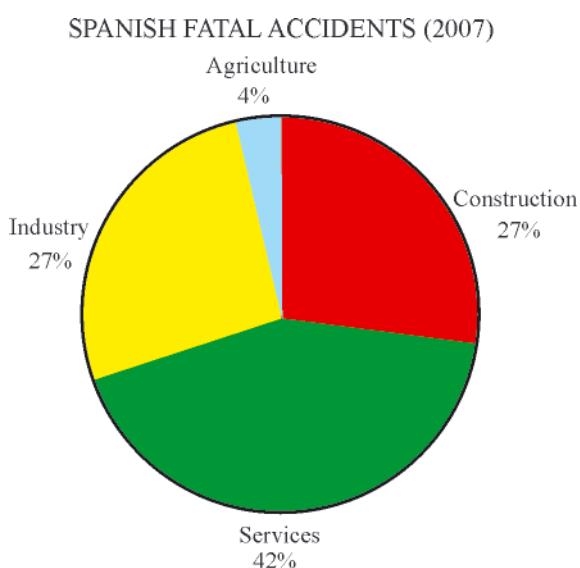
Fig. 1. Spanish total accidents in 2007 (obtained from [3])

the rest divided between the industrial and agricultural sectors, as Figs 1 and 2 show. In particular, Spanish maritime accidents have increased in the last decade from 326 accidents in 1992 to 566 in 2000 [1]. According to Fig. 3, we can conclude that commercial fishing fleets fatal accidents have been substantially

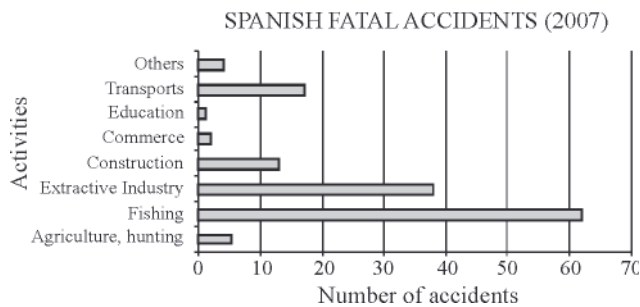
Fig. 3. Fatal accidents in Spain in 2007 year by activities - for one hundred thousands of Workers (obtained from [3])
