LRT urban insertion and safety: European experiences

This paper provides a rough design toolkit for improving the safety of LRT (Light Rail Transit) urban insertion. This toolkit has been prepared after the analysis of more than 130 examples of good and bad practices related to LRT urban insertion in 13 European countries, which have taken place during the first working phase of the COST Action TU1103, “Operation and safety of tramways in interaction with public space”.

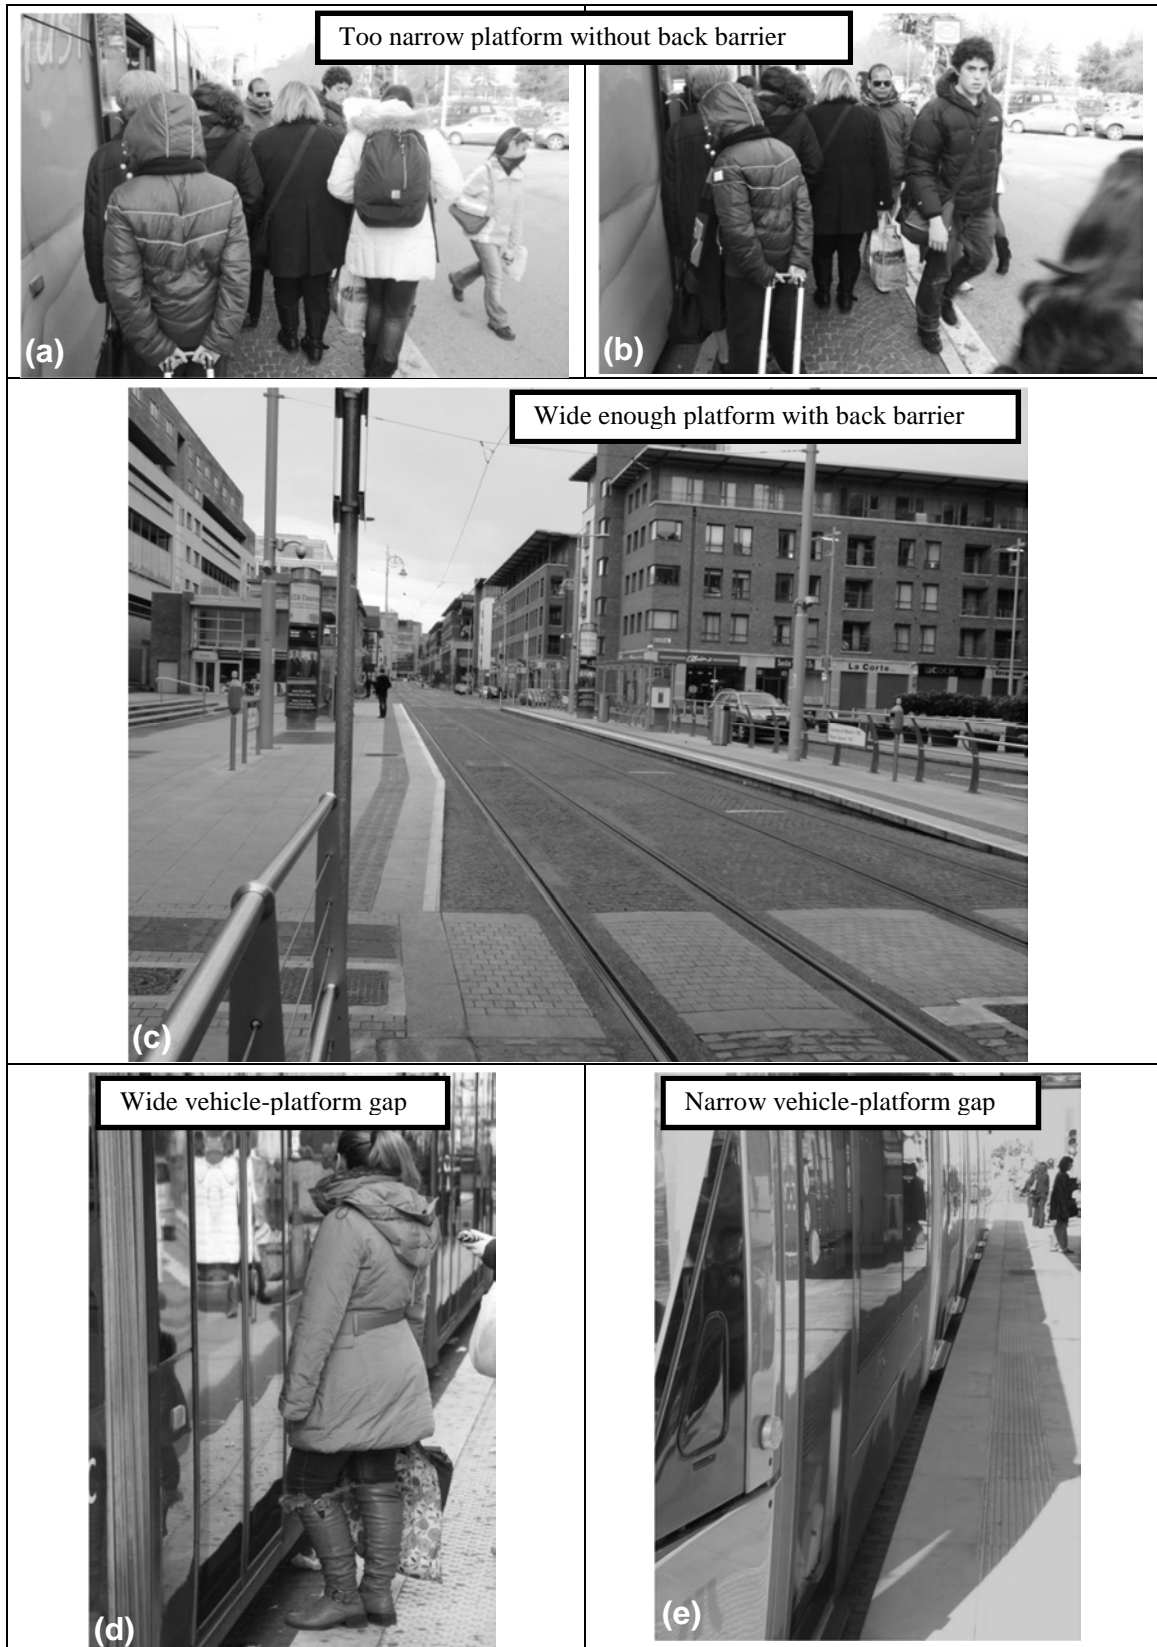
FIGURE 2 Platform design and station/stop location. a&b) Narrow platform without back barrier in Rome (Italy); c) Good platform design with back barrier in Dublin (Ireland); d) Excessive platform-vehicle gap in Rome; e) Narrow platform-vehicle gap in Tenerife (Spain); f) Back platform drainage channel in Dublin; g&h) Interchange between bus and LRT in the same platform in Marseille (France).

Platforms should be wide enough to have room for all the users. Additionally, when there is a road lane at the back of the platform, it is advisable to provide a barrier in order to prevent users stepping off the platform into the road lane. Bad and good practices are presented in Figures 2a to 2c.

On the other hand, the closer the platform to the LRV the better, not only from the safety point of view, but from the operational one (quicker boarding and alighting leading to shorter stop times). Several examples are presented in Figures 2d and 2e.

Additionally, platforms should have an adequate fall in order to get a good drainage. The longitudinal fall should preferably be minimum 0.5% and transversal fall 2.5% towards back of the platform (away from track), in order to avoid the possibility for a wheelchair to fall on tracks by an unnoticed movement caused by the slope. This design imposes the need for an additional drainage channel on back of platforms (Figure 2f).

Finally, the platform location and design is a key point to take into account at interchange stations. Figures 2g and 2h show a good design of an interchange between bus and LRT with its explanation.

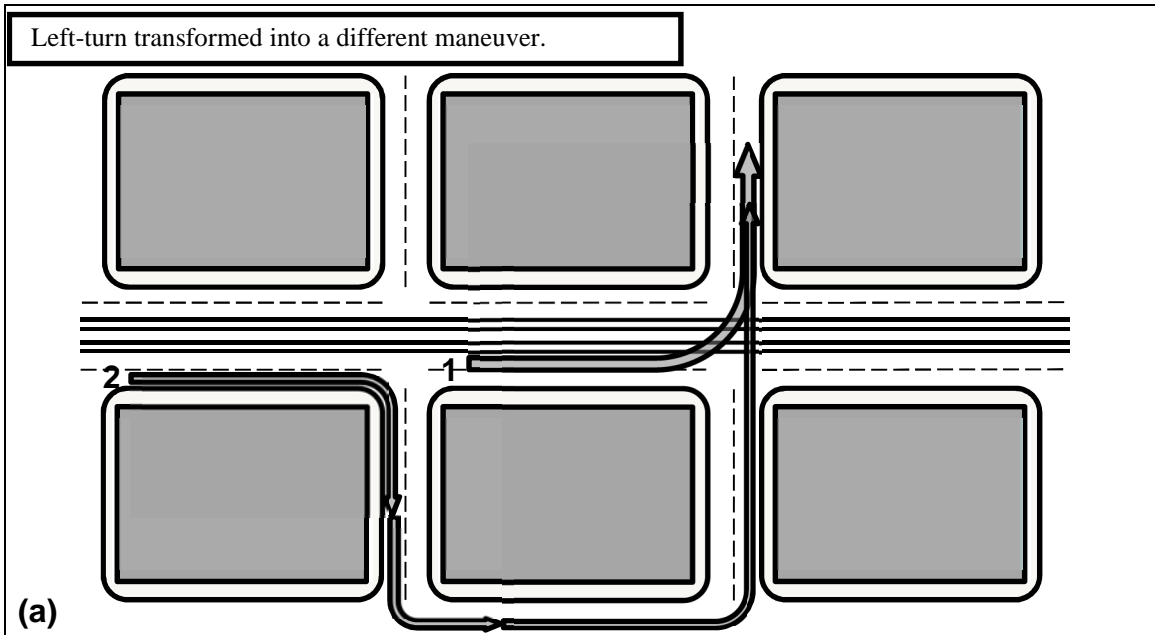
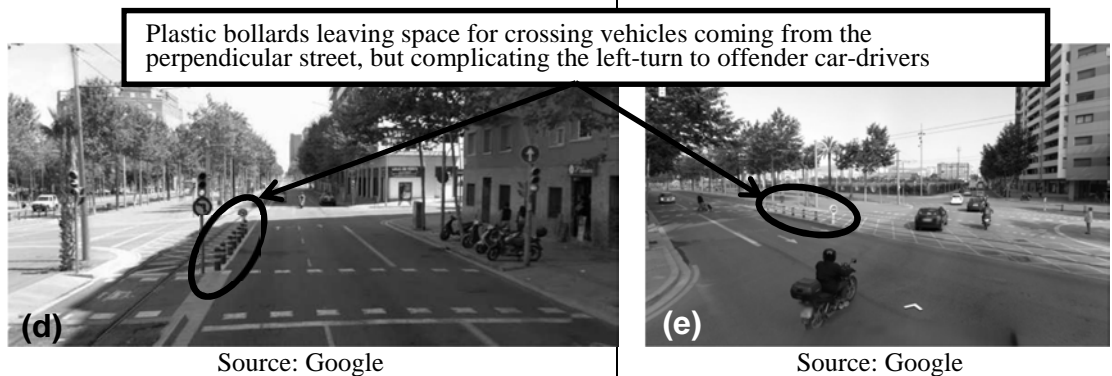
FIGURE 5 Left-turn intersections. a) Transforming a left-turn intersection into another kind of maneuver; b&c) Transforming a left-turn into a perpendicular intersection in Porto; d&e) Avoiding forbidden left-turns by means of bollards in Barcelona; f,g&h) Improving traffic lights readability in Montpellier.

In order to avoid this kind of movements, left-turns are sometimes transformed into a different maneuver where the car-driver crosses the LRT channel in a perpendicular way (either arrow 2 instead of arrow 1 in Figure 5a or three right turns starting beyond the cross street).

Another way of converting a left-turn into a perpendicular crossing is the one presented in Figures 5b and 5c, where a green space is designed to force road vehicles to enter the junction at right angles, allowing better visibility of approaching LRVs. This solution is simple and easy to implement, if the needed space is available.

In any case, as some road vehicle drivers tend to disobey the left-turn prohibition, sometimes additional measures accompany the signals (Figures 5d and 5e).

Figures 5f to 5h show the case of a left-turn intersection in Montpellier (France), where a specific left-turn lane is provided. In the operation of traffic lights, straight-on vehicles and left-turn vehicles do not pass at the same time: green light for straight-on vehicles is given at the same time as green light for LRT, while left-turn vehicles must stay stopped in this phase of the traffic light cycle. The stop line for straight-on vehicles (and their traffic lights) is set back 5 m from the left-turn stop line. This avoids the risk that the left-turn car-driver starts at the same time as the vehicles near him/her, thinking that the green light for straight-on vehicles applies to him/her too, and colliding with the LRV that is running straight-on on its tracks.

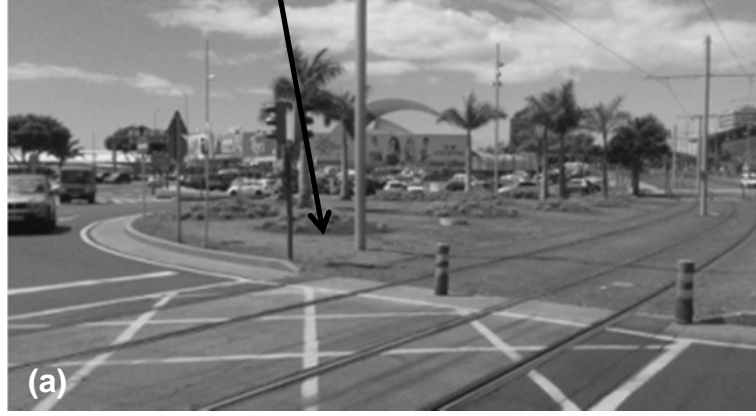
(a)

Low height vegetation to avoid visibility problems between road vehicles and LRT drivers in the junction of the roundabout

Nevertheless, the junction operation changes when a LRT system is added to the roundabout. LRT is usually implemented running through the roundabout center. The roundabout works as a conventional one when LRVs are not present, but traffic lights are provided to give LRVs priority when they approach the roundabout. One important issue is the need to avoid the misreading of the roundabout and the traffic lights by car-drivers, which can easily lead to an accident or incident. On the other hand, it is important that car-drivers encounter the LRT channel as near to the perpendicular direction as possible, to improve the visibility and awareness of the LRT presence. Additionally, if vegetation is provided in the roundabout, the use of tall trees and species should be avoided to guarantee a good visibility between road vehicle and LRV drivers. The recommended covering is grass or low shrubbery (see Figure 6a).

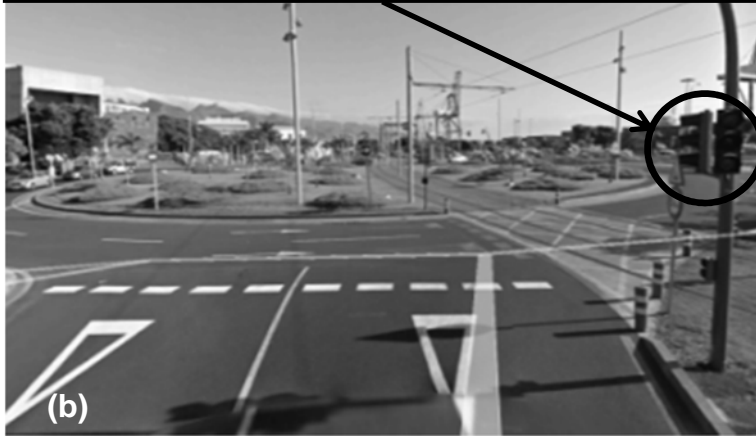
(b)

Traffic light orientation appropriate for avoiding misreading: drivers that come from the incoming road do not see the traffic lights that belong to the junction (and vice versa)

Figures 6b and 6c show the traffic light treatment used for roundabouts in Tenerife (Spain).

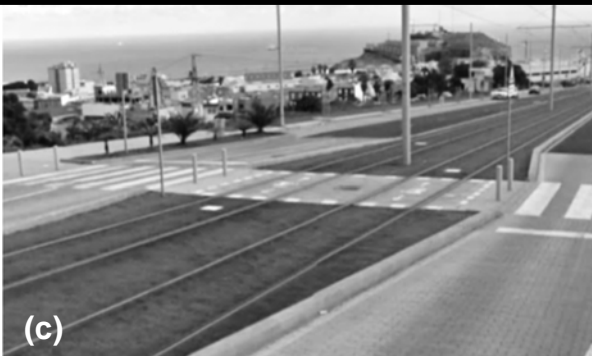
Z-crossing: it obliges pedestrian to cross the tracks facing always the direction of the incoming LRV, in such a way that it is very difficult not being aware of an approaching LRV

Figures 7c and 7d show a well-designed pedestrian crossing in Tenerife (Spain), while a common solution in some German cities (Z-crossing) is presented in Figure 7e.

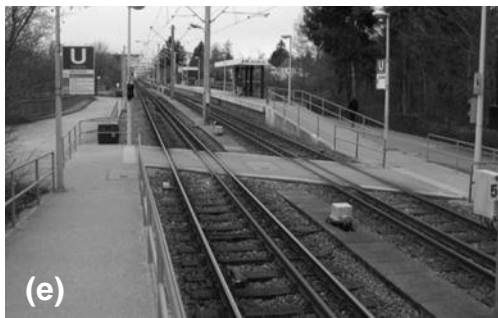
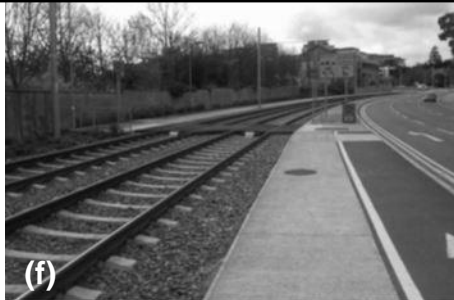
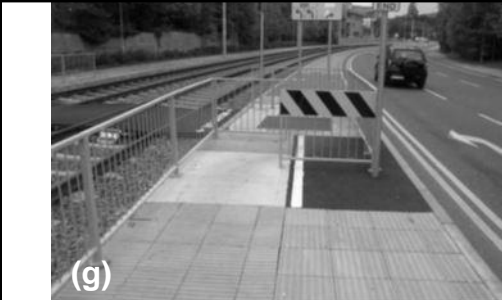
Change in a pedestrian + cyclist crossing to avoid crossing the LRT channel in one movement, obliging cyclist to initiate the crossing of the tracks in a perpendicular direction.

A change in a pedestrian and cyclist crossing design to improve safety is presented in Figures 7f and 7g. In this zone a pedestrian footpath and a cycle lane run adjacent to a segregated channel of Dublin LRT. Due to the configuration of the carriageway, the footpath and the cycleway changes sides of the track along this segregated section. Cyclists entered the crossing in one movement, without stopping and looking for oncoming LRVs, creating hazardous situations. It was decided to install a chicane to slow cyclists down and to force them to approach the tracks at right angles. Before implementing this solution, RPA (Railway Procurement Agency) carried out CCTV to observe cyclists behavior and RPA/Veolia/Local Authority installed a mock-up with cones to trial proposed installation before construction.

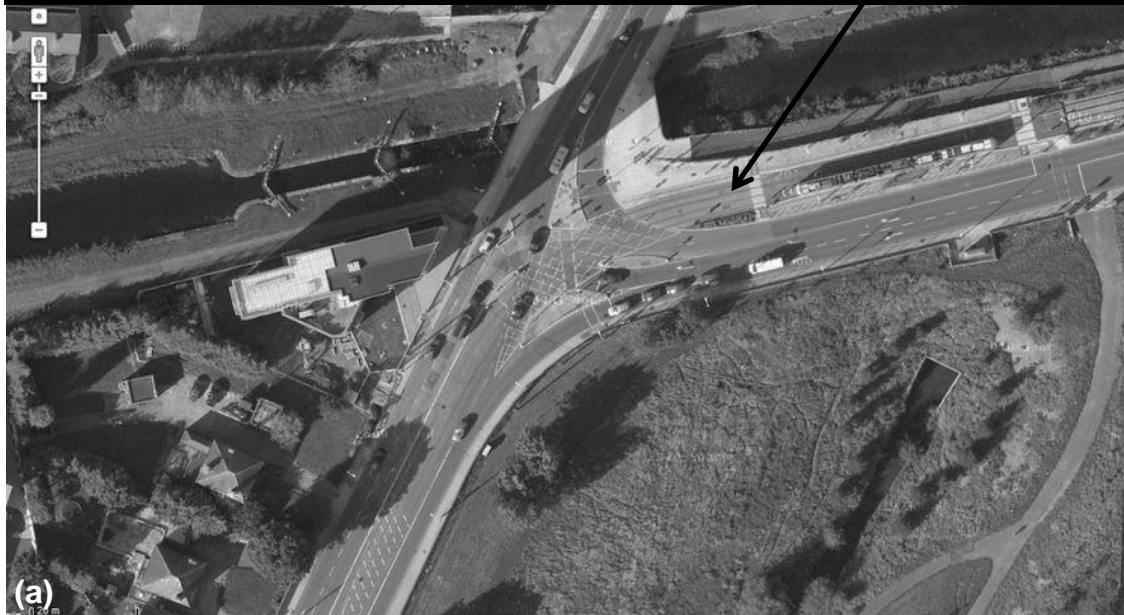
(a)

To warn road users, the entrance to this section is marked with warning signs and the surface at the entrance is covered with a deterrent paving of red cobbles set into the surface. If road vehicles enter the segregated area, driving over the deterrent paving will make the driver aware that he/she has left the road surface. Nevertheless, the warning signs and deterrent paving do not prevent road vehicles entering the segregated section on purpose.

Figures 9a to 9c show a road junction with the explanation of the measures taken to avoid road vehicles to enter the segregated LRT tracks. Figure 9d shows the differentiation of the segregated channel by means of the pavement treatment. Figure 9e shows the demarcation of the swept path in a shared channel by using yellow dots painted onto the road surface.

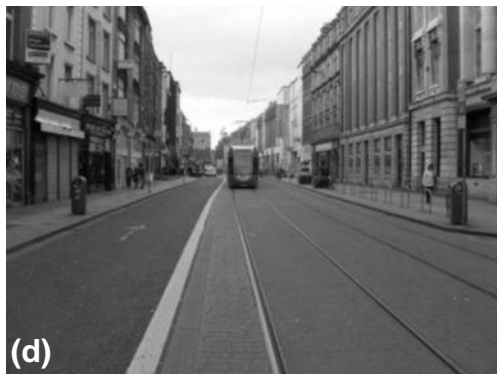
(d)

Differentiation of segregated channel by means of the pavement treatment (use of cobble stones and a difference in levels). The continuous white line demarcates the swept path.

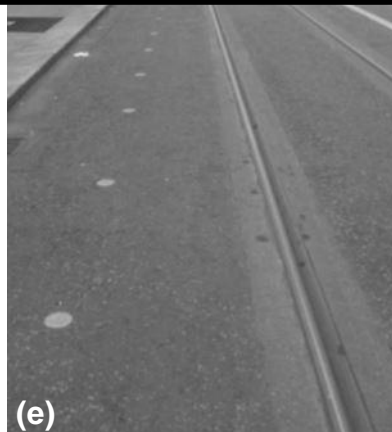
(e)

Demarcation of the swept path in a shared channel by using yellow dots painted onto the road surface
