# Disasters, Memory and Liturgy. Liturgical Spaces in the Reconstruction Process of Historical Churches Damaged by Earthquakes

Giulia De Lucia· Politecnico di Torino (Turin, Italy), giulia.delucia@polito.it

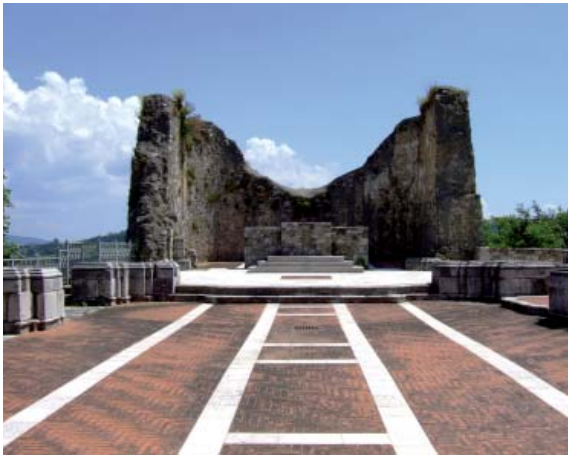
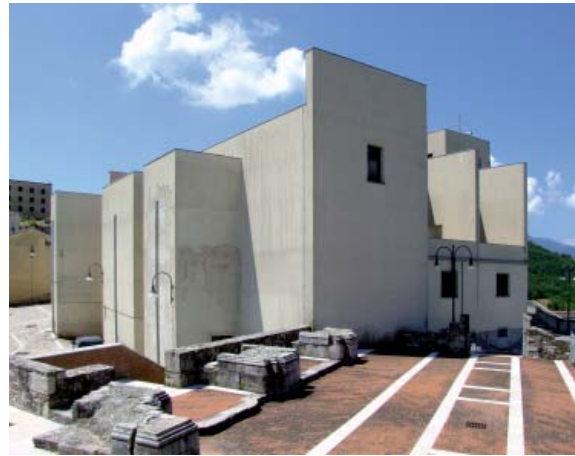
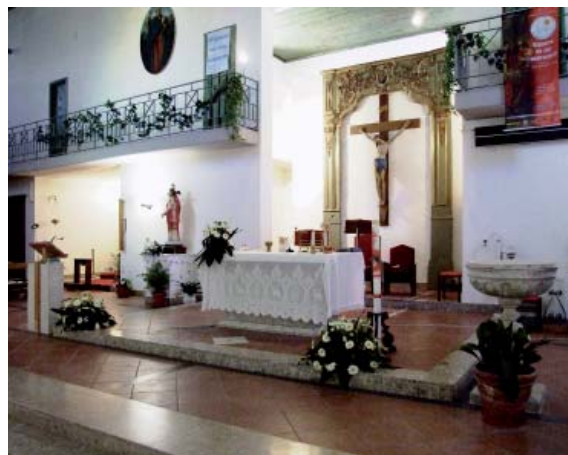
Fig. 03-04. Giorgio Grassi. Chiesa Madre, Teora (Italy), 1981-83/2011.

Fig. 05-06. Giorgio Grassi. Chiesa Madre, Teora (Italy), 1981-83/2011.

reconstruction was planned in compartments, totally changing the historical conformation of the towns. Some part of the historical settlement could not be rebuilt. For this research is interesting the case of the new church, designed by Giorgio Grassi over the same area of the old church. In this way, the Mother Church of Teora is linked to the past and the memory of the settlement. The destroyed church was left as a ruin and it is used a large churchyard instead (Crespi and Deگو 2004). Also in this case the old church artistic objects have been transported into the new church (Fig. 03-06).
